## **Appendix C**

### **Photographs**

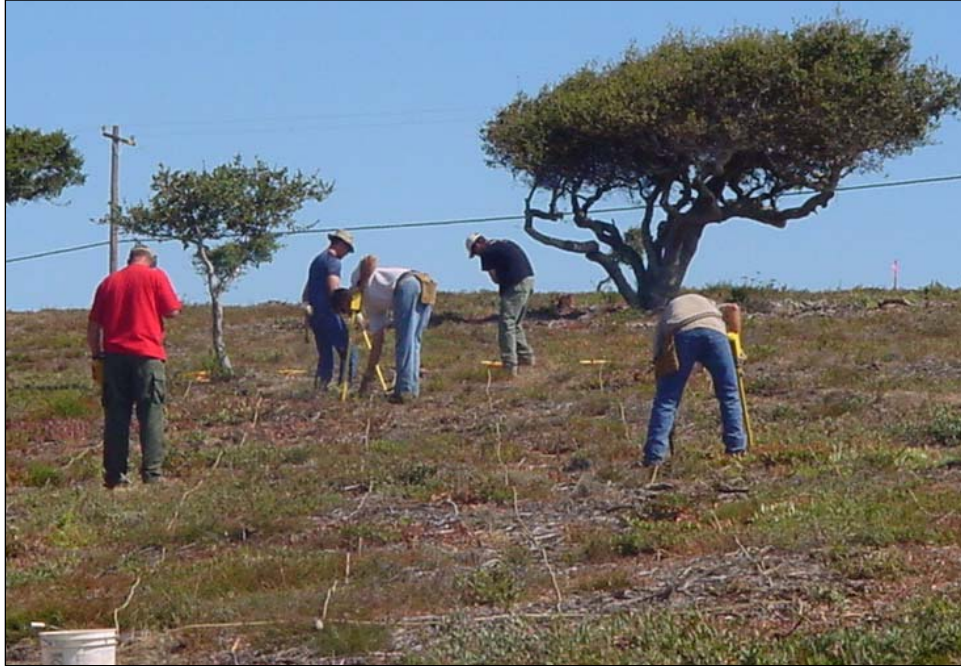
Photograph 1: UXO teams operated Schonstedt magnetometers over three-ft-wide search lanes to detect subsurface MEC on MRS-MOCO.2.

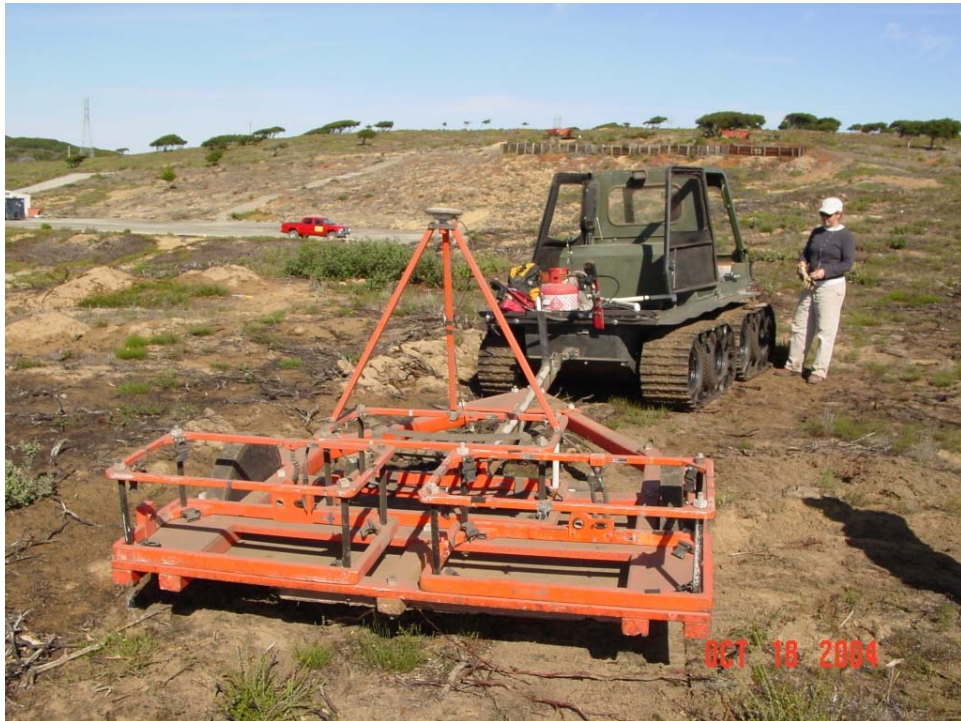
Photograph 2: Geophysics teams used the towed-array EM61-MK2 system to survey Special Case Areas in MRS-MOCO.2 because the system is not affected by asphalt and it efficiently collects data.

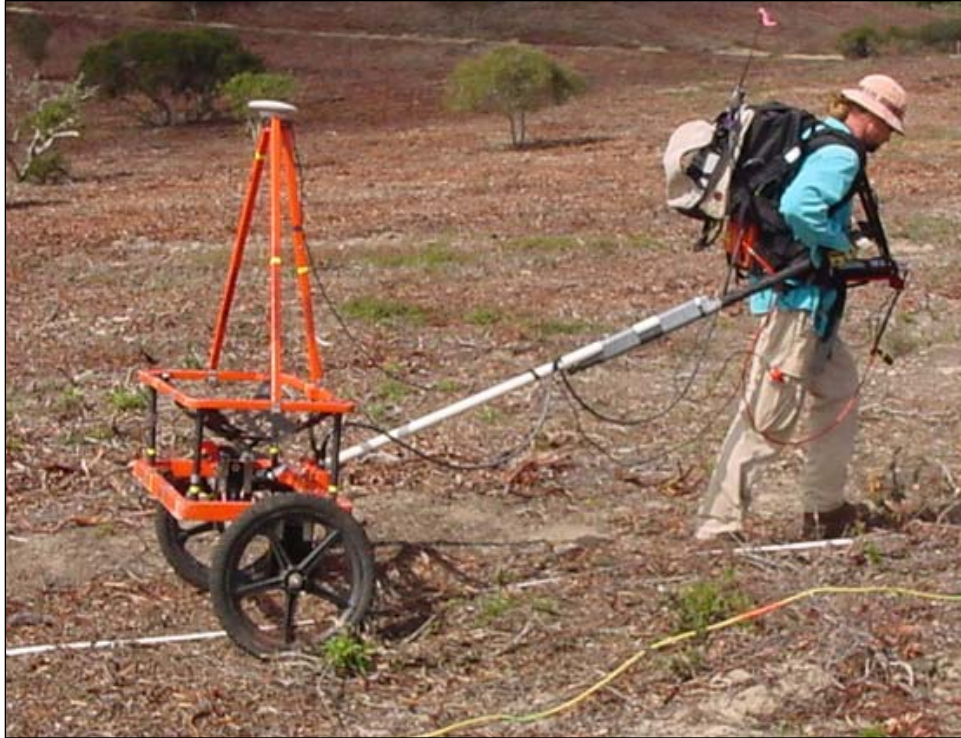
Photograph 3: Technicians used the individual EM61-MK2 system to survey SCAs in MRS-MOCO.2 in places where the towed array was not effective due to terrain or obstacles.

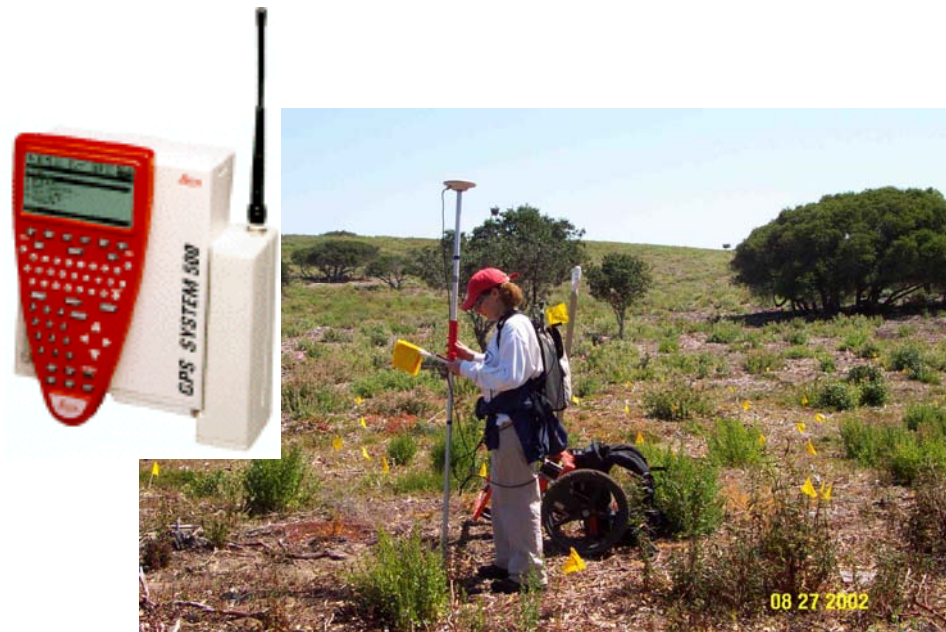
Photograph 4: A Leica GPS receiver was attached to the digital survey instruments to accurately record the locations of data collection points, enabling anomalous areas to be found easily with the GPS for later verification and excavation.

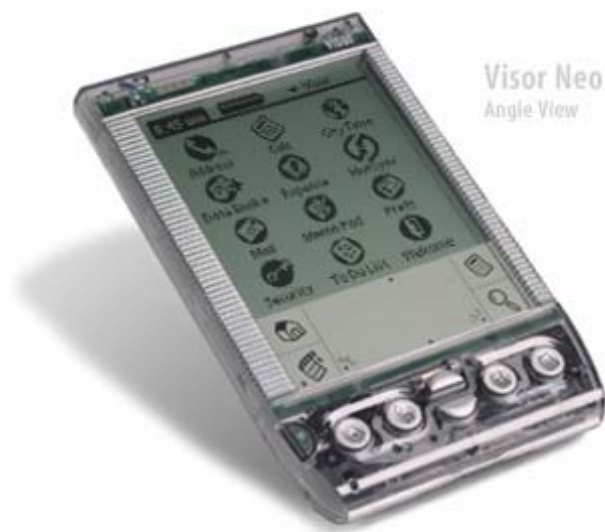
Photograph 5: The Handspring Visor PDA was used to record survey information as well as anomaly reacquisition and QC-1 results.

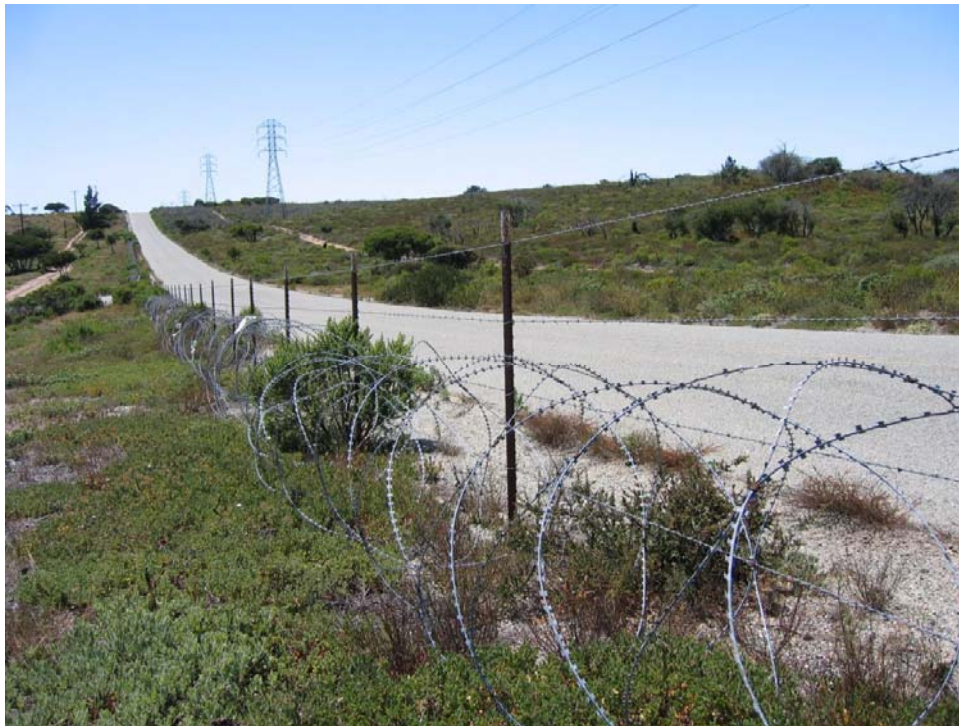
Photograph 6: Because this metal fence interfered with geodetection instrument operation, it was dismantled and disposed of before MEC detection and removal within a 25-ft-wide corridor along Eucalyptus Road. A temporary orange plastic-mesh fence 30 ft south of the road contributed to site security until completion of MEC removal and QC/QA, when a new concertina-wire fence was installed along Eucalyptus Road.

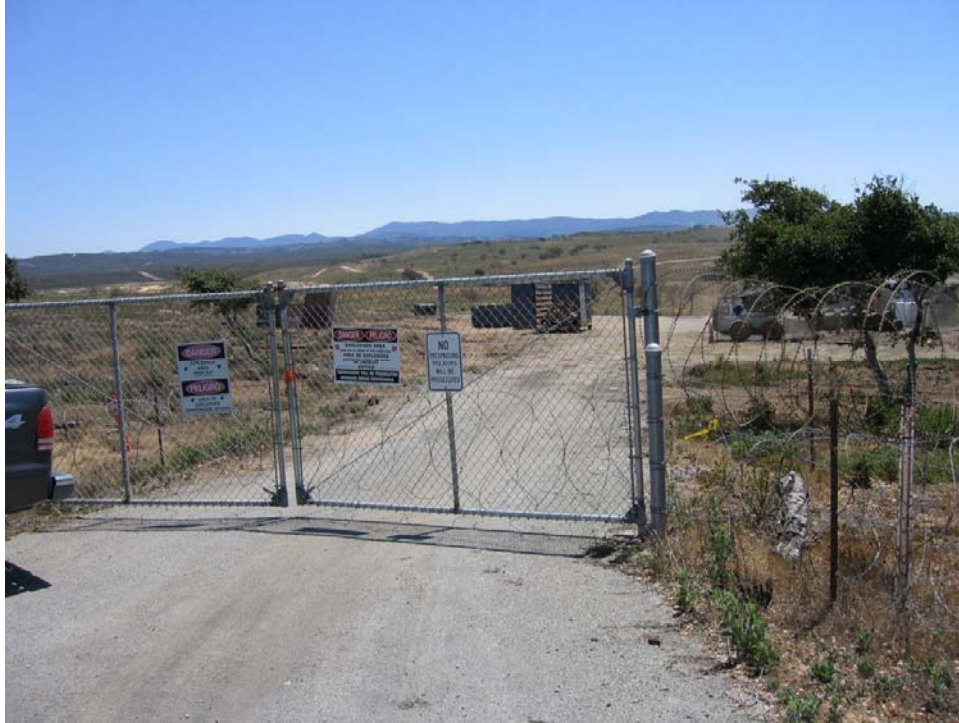
Photograph 7: This gate at the Range 44 pad and the gate at the Range 45 pad were taken down and stored during MEC detection and removal, then reinstalled after completion of QA.

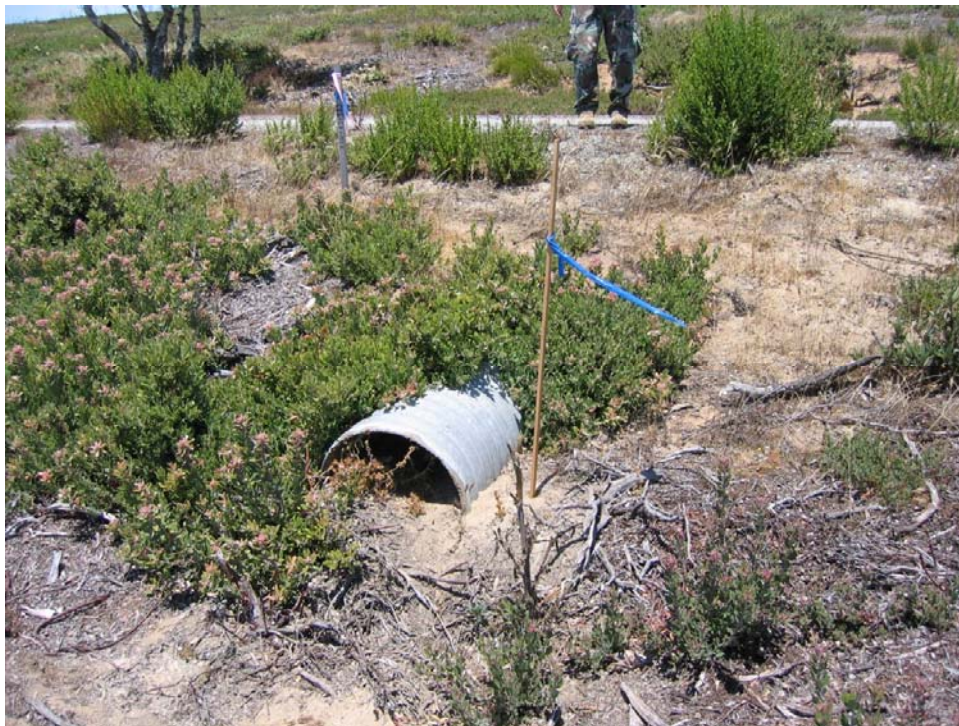
Photograph 8: Removal of this 18-inch culvert allowed analog removal followed by digital geophysical mapping and excavation of anomalies that could not be detected during Phase 1, including the area where the asphalt road was removed to provide access to the culvert.

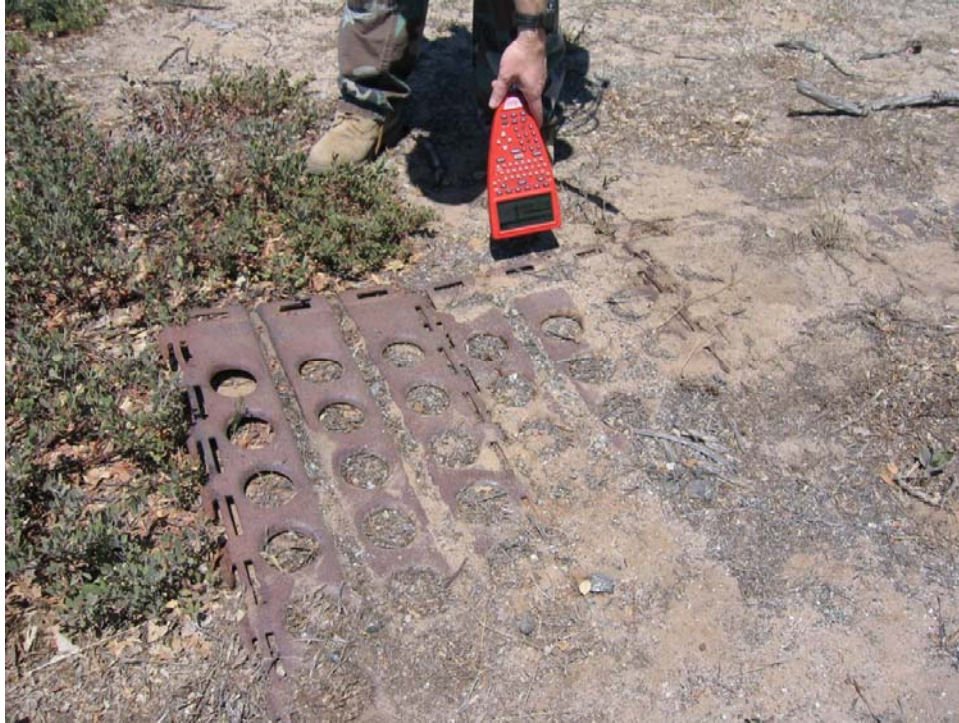
Photograph 9: Removing this PSP mat and the asphalt above it allowed analog removal followed by DGM and excavation of anomalies in this section of road.

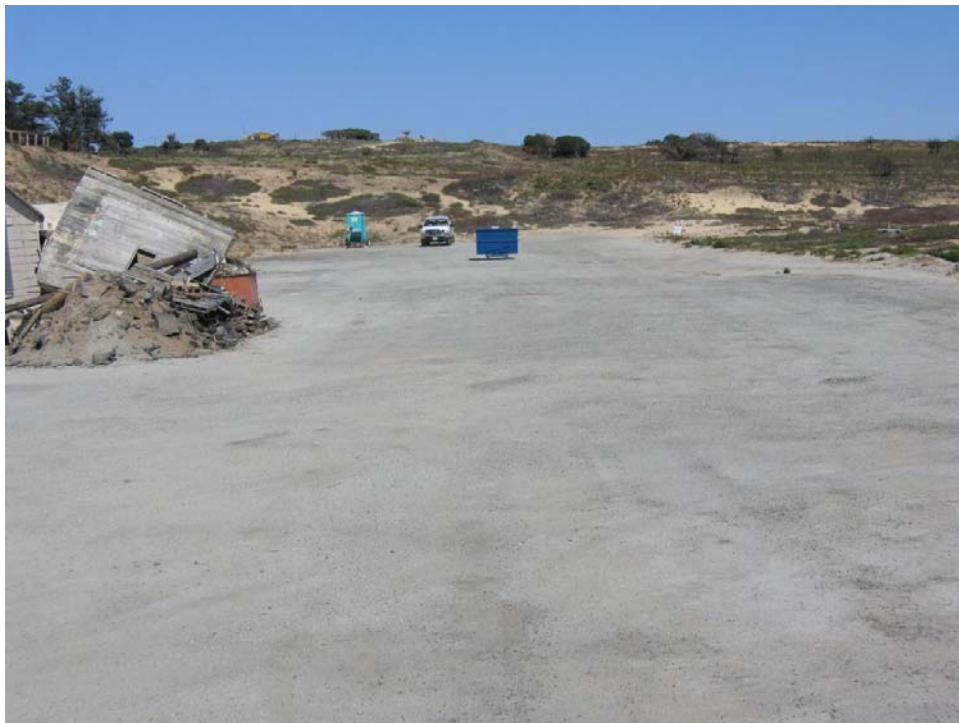
Photograph 10: Prior to Phase 2, debris was removed from asphalt areas, such as Range 45 shown here. Areas where asphalt was torn out received analog removal before DGM. Most pavement was left in place and received DGM using the EM-61MK2 followed by excavation, which tests showed to be an effective means for finding and removing anomalies.

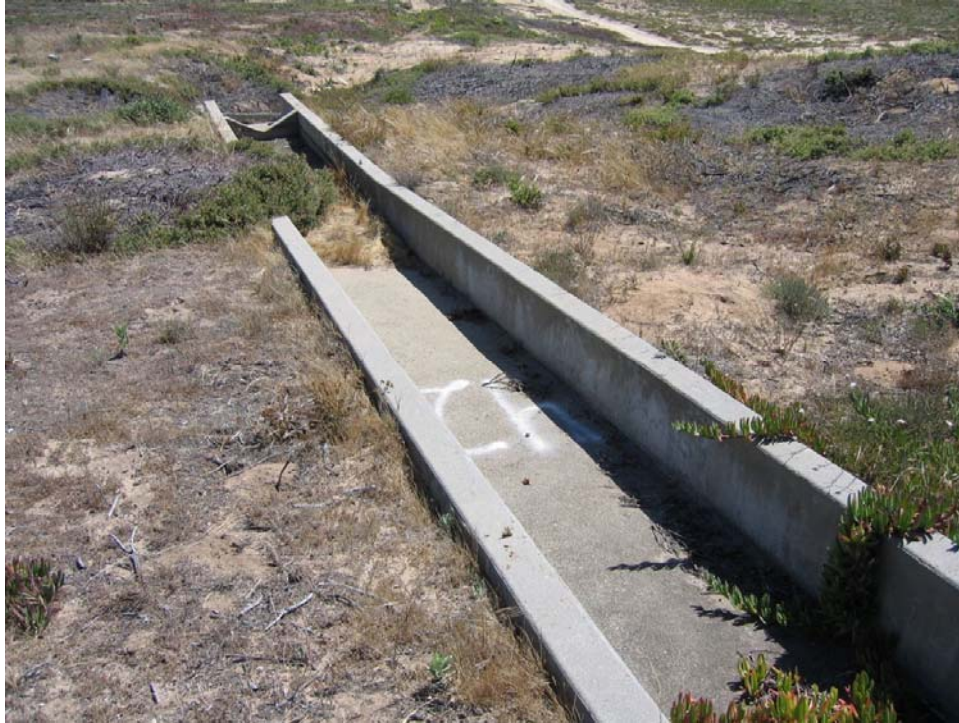
Photograph 11: Removing concrete obstructions such as this drain at SCA 12 allowed UXO teams to perform analog removal followed by DGM and excavation, further reducing any threat to public safety from the potential presence of MEC.

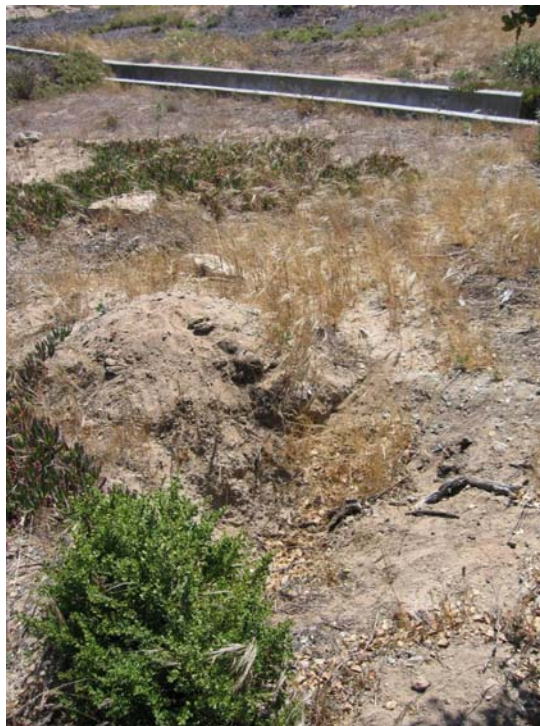
Photograph 12: Heavy equipment excavated the fill in SCA 26 to depths up to eight feet, after which the fill was spread on the Range 46 pad for extraction of metallic debris before processing through a sifter with a  $\frac{3}{4}$  inch screen to remove potential MEC.

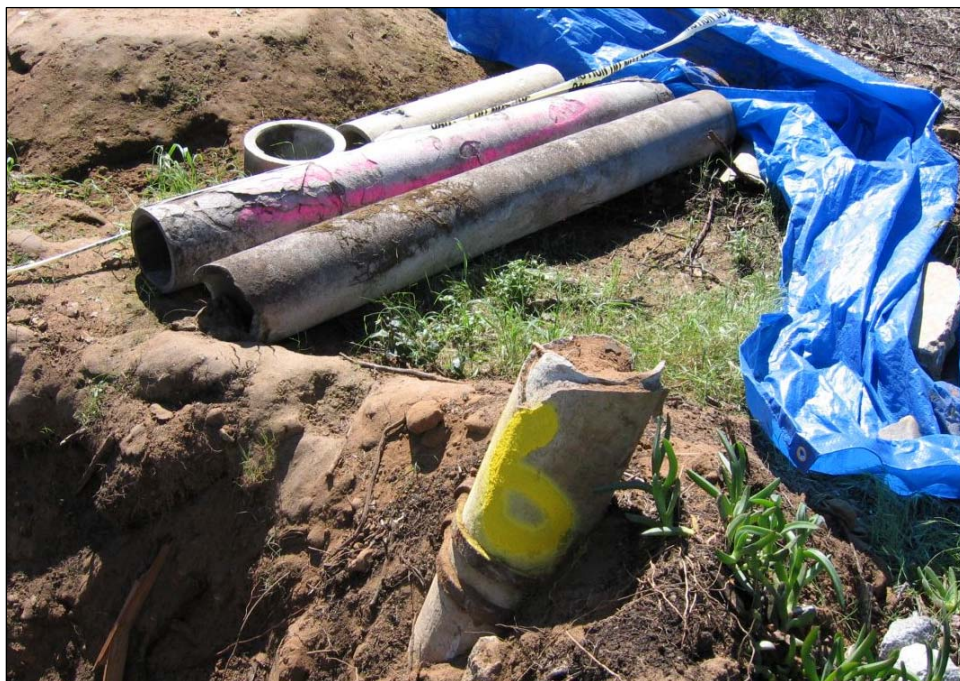
Photograph 13: To prevent possible exposure of UXO teams to asbestos, these transite pipes were wrapped and transported offsite as non-hazardous waste for disposal before analog removal, DGM and excavation, and the QC/QA process.

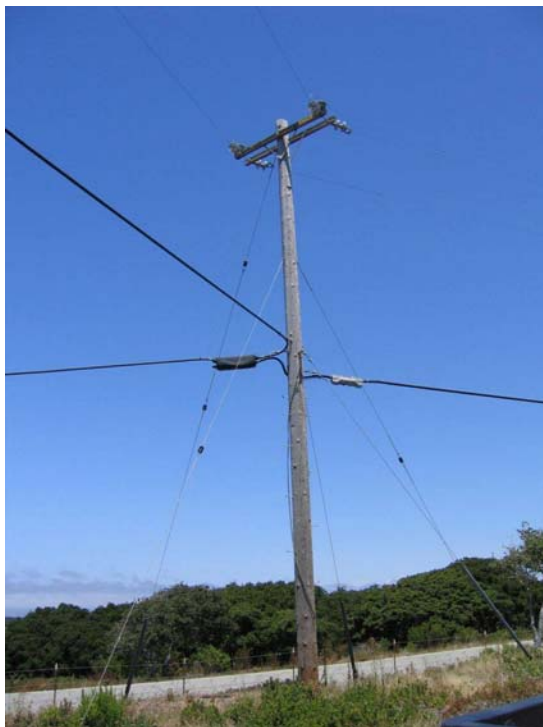
Photograph 14: Because utility poles and pole anchors in three grids could not be removed within the scope of the action, removal and QC operations were performed as close as possible to the obstacles (approximately six ft) and the grids were assigned a status of TBD.
